# Community Preservation Committee Town of Arlington

Project Title: **Study of Spy Pond Field Bleachers**

## **SPY POND FIELD Assessment of Concrete Bleachers**

### **Final Report**

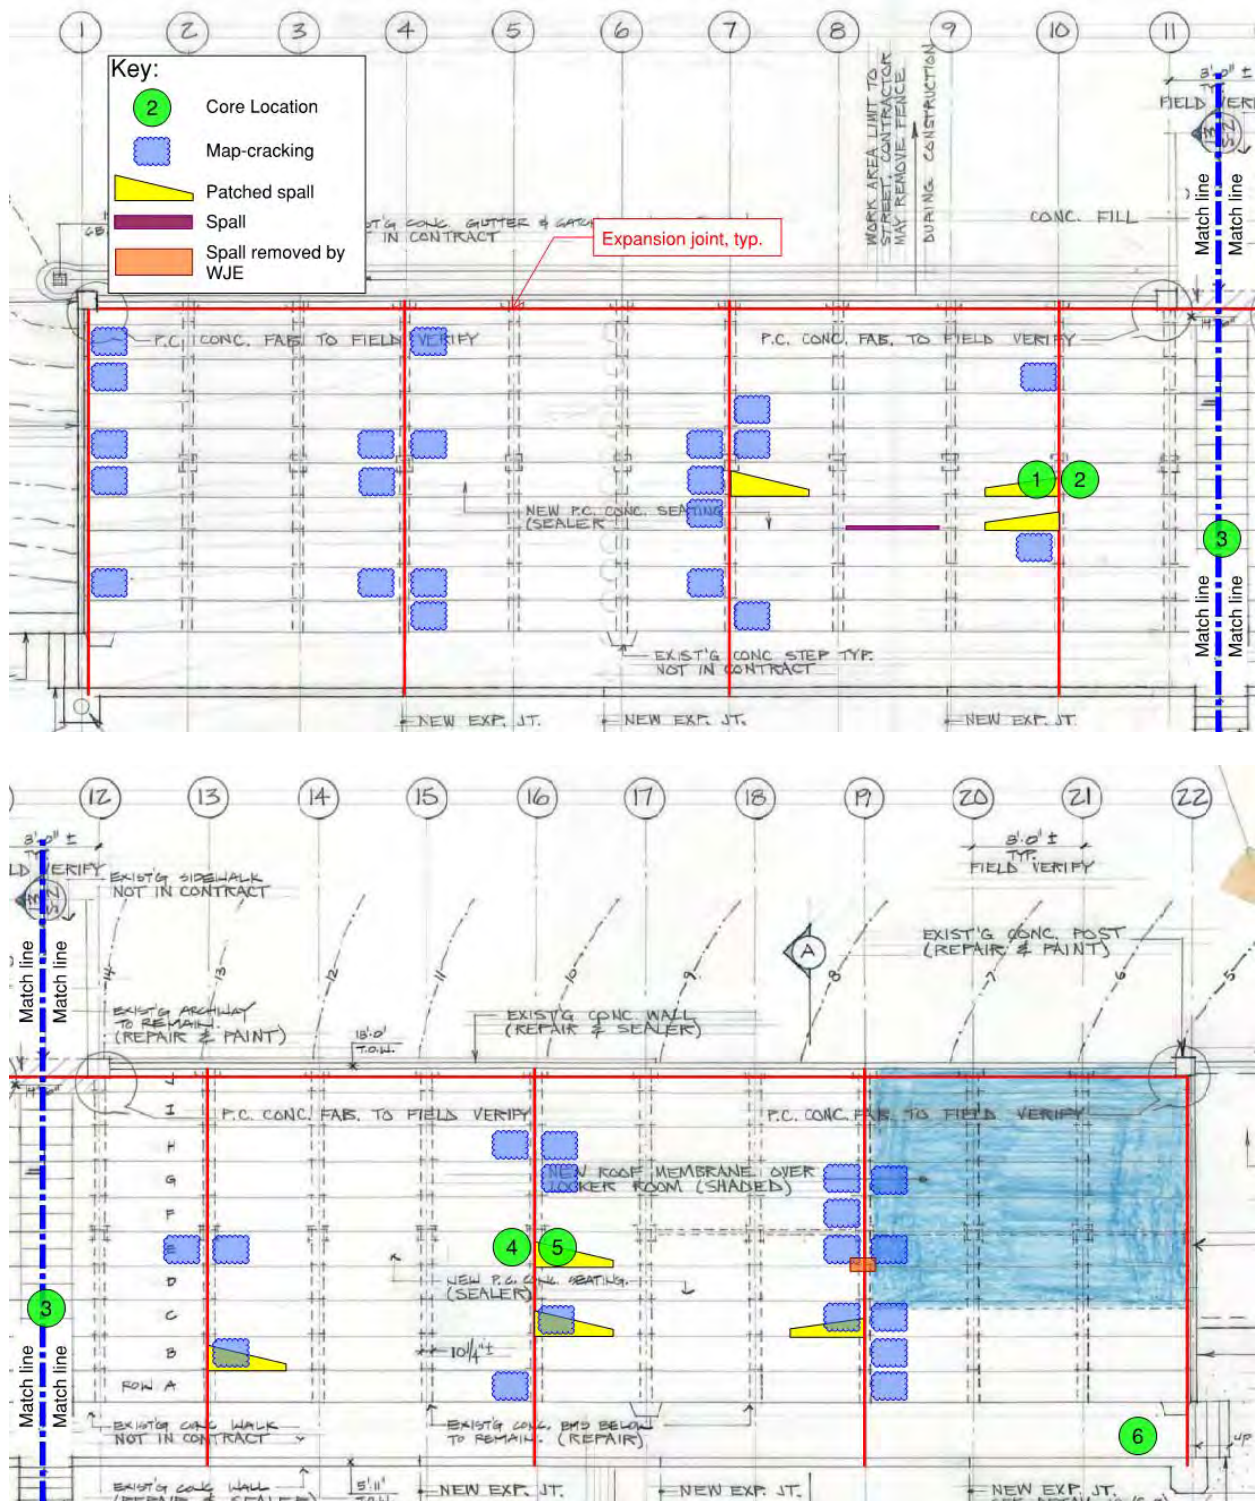
Figure 38. Plan view of precast concrete bleachers with locations of concrete cores, map-cracking, and spalls indicated.

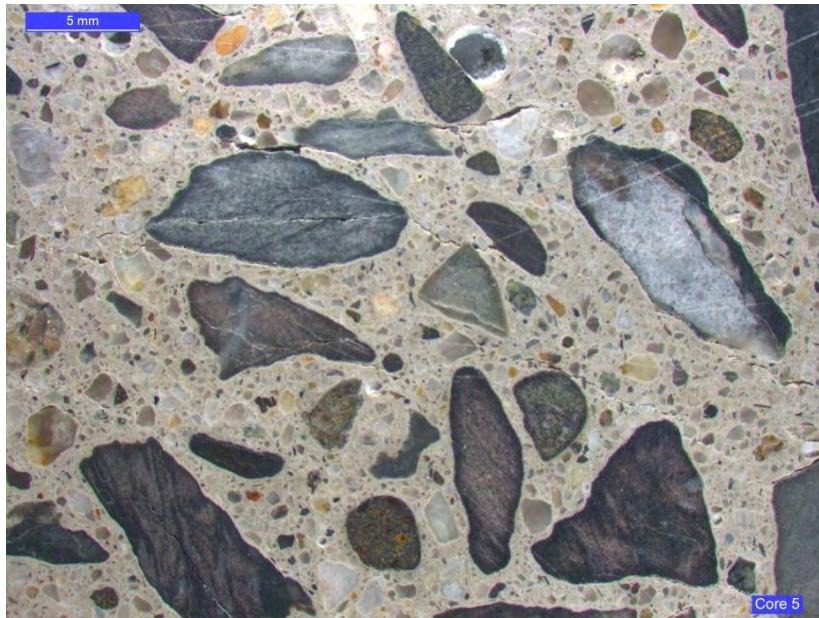
*Figure 3. The lapped surface of Core 5 is pictured. The coarse aggregate consists of fine-grained metamorphic rocks known to be potentially reactive to alkalis. The aggregate is consistent between Cores 1-6. ASR was detected in Cores 1-5.*

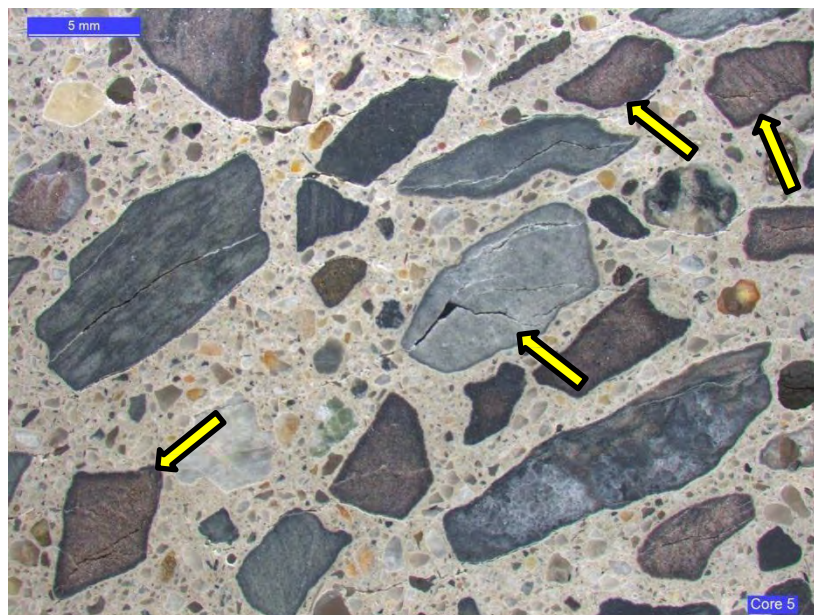
*Figure 4. A portion of the lapped surface in Core 5 is pictured. Some coarse aggregate particles have darkened rims around their perimeter (arrows) suggesting a reaction with the aggregate has taken place.*

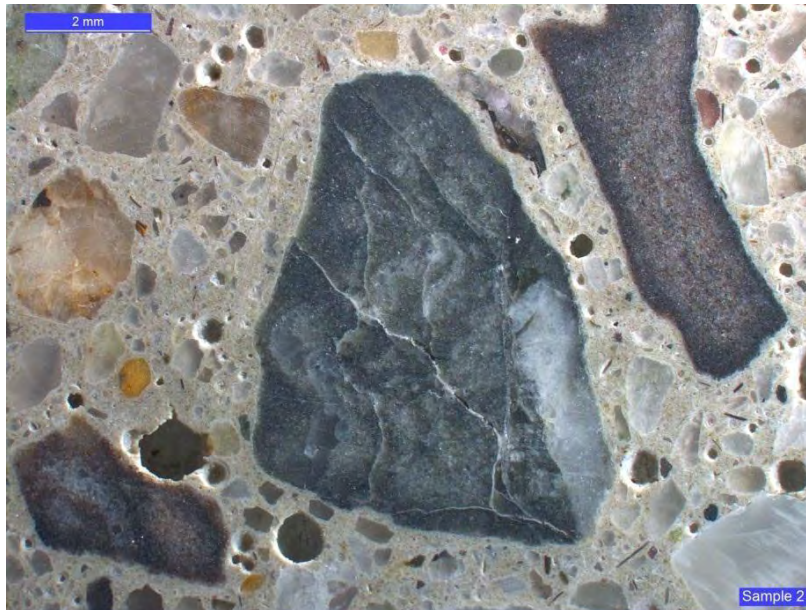
Figure 5. An aggregate on the lapped surface of Core 2 is pictured. The aggregate contains numerous internal fractures.

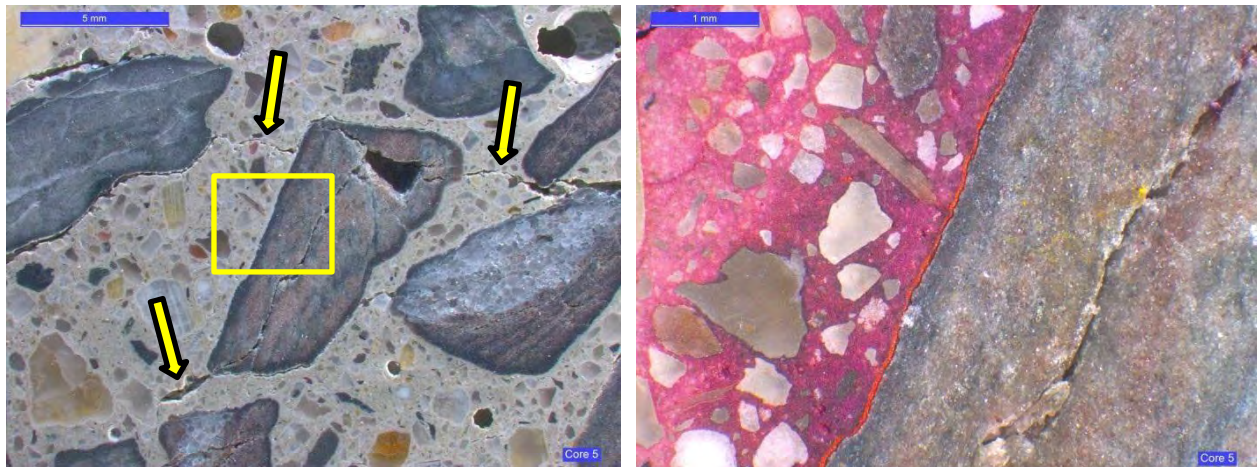
Figures 6a and 6b. An aggregate on the lapped surface of Core 5 is pictured on the left. The boxed region is pictured at higher magnification and after the application of Alizarin Red S dye on the right. Freeze-thaw induced cracks are marked with arrows and intersect the aggregate particle. The aggregate is surrounded by a thin band of secondary deposits of ettringite (stained orange with dye).

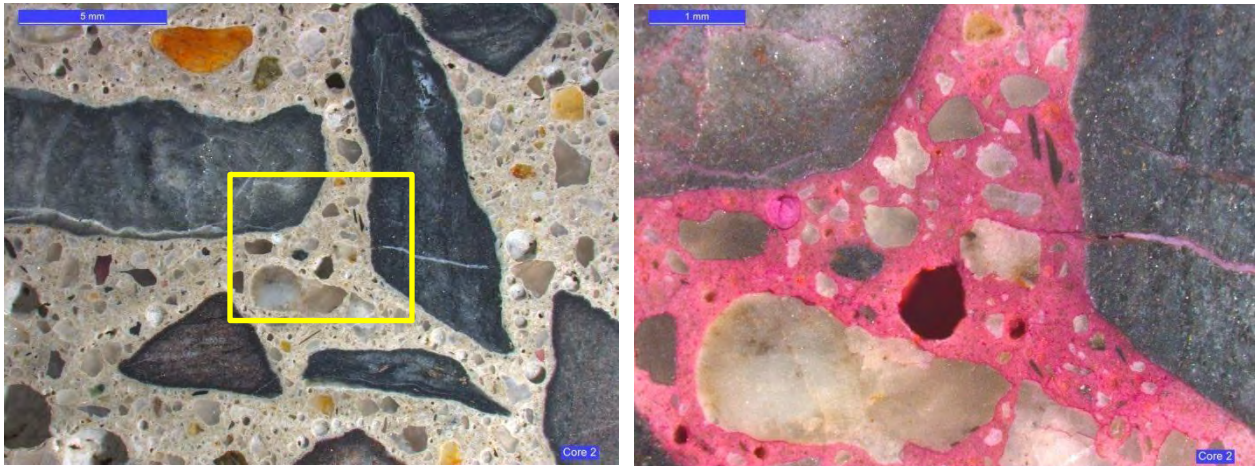
Figures 7a and 7b. A portion of the lapped surface in Core 2 is pictured on the left and the boxed region at higher magnification and after the application of Alizarin Red S dye on the right. Internal fractures through aggregates extend into the adjacent cementitious matrix and are filled with gel. The gel stained red, indicative of calcium-containing gel.

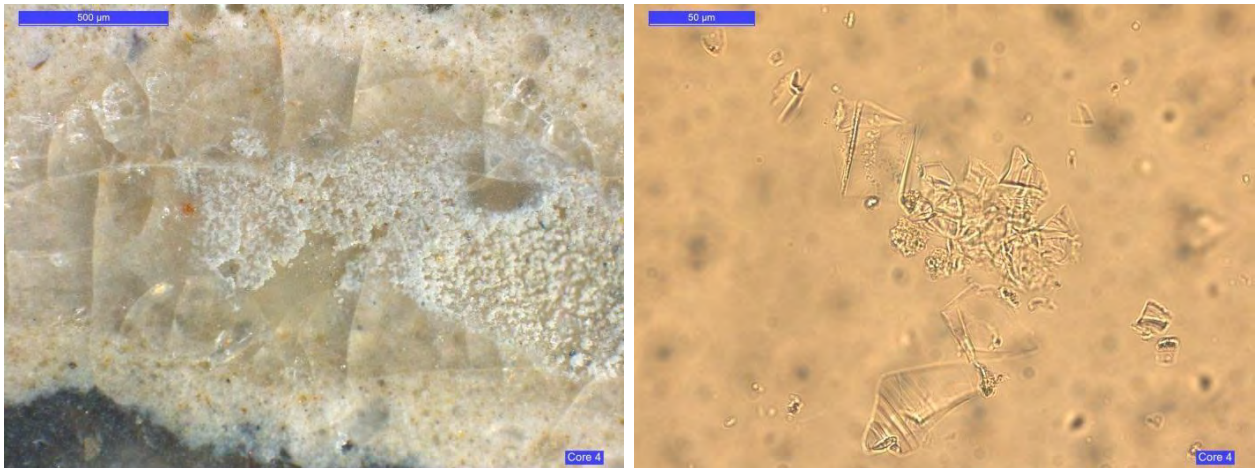
Figures 8a and 8b. An irregularly-shaped void filled with secondary deposits in Core 4 is pictured on the left. The deposits were scraped from the surface of the lapped surface and examined using a polarized light microscope with a refractive index oil of 1.49. The fragment immersed in oil is pictured with transmitted light on the right image. The deposits had a refractive index less than 1.49, had a low relief and were isotropic. These features are consistent with ASR gel.

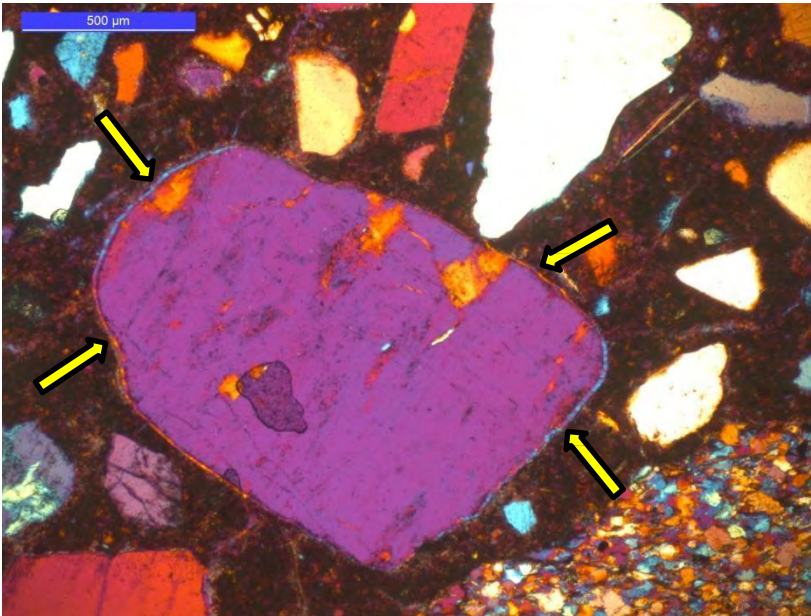
Figure 9. A portion of the thin section of Core 5 using cross-polarized light with the gypsum plate is pictured. The coarse aggregate particle is fully surrounded by a thin void filled with a secondary deposit (arrows). The deposits had features consistent with ettringite.

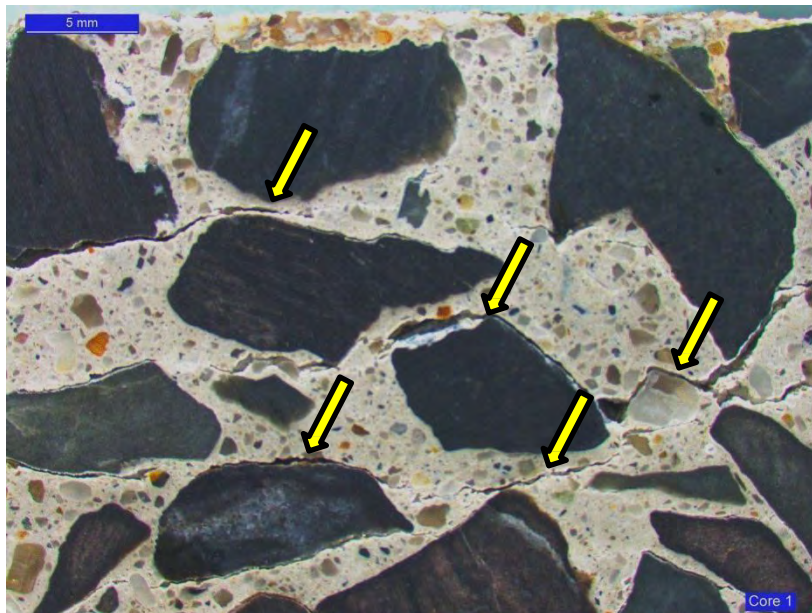
Concrete samples 1 and 5 are non-air-entrained and contain fractures that are indicative of advanced freeze-thaw distress. Secondary deposits that coat these fracture surfaces confirm that moisture has migrated through the concrete. Although samples 2, 3, and 4 are air-entrained, secondary deposits were detected in many of the air voids. In addition to the variation in air entrainment, there is also a variation of the constituent volumes of materials from sample to sample.

Figure 10. A portion of the near-surface region of Core 1 is pictured. Macrocracks oriented parallel to the top surface and parallel to one another are marked with arrows. Cracking extended through the full core width. This crack pattern is typical of freeze-thaw distress.

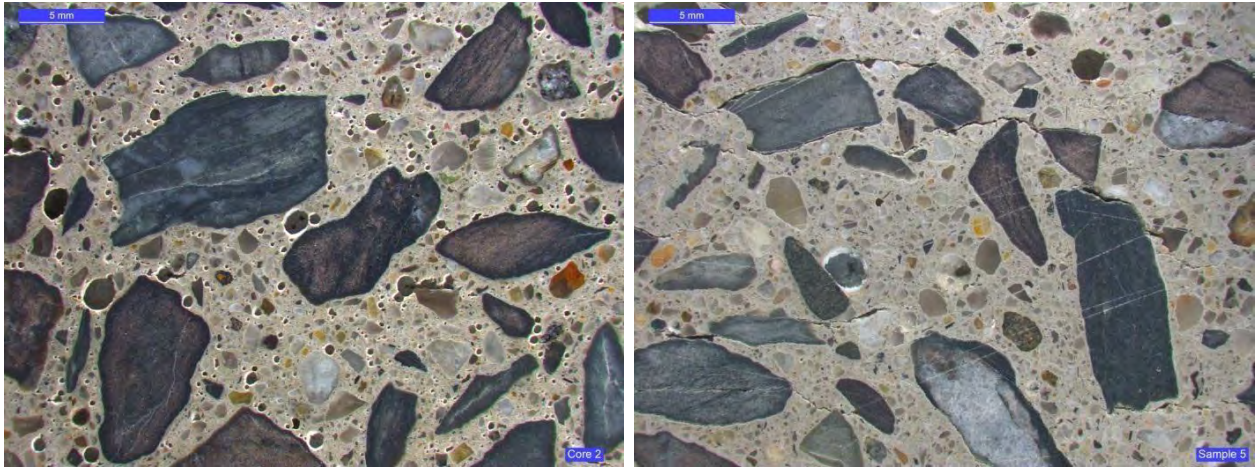
Figures 11a and 11b. A portion of the lapped surfaces of Core 2 and Core 5 is pictured on the left and right, respectively, using low-angle lighting. Voids appear as dark spots. Core 2, along with Cores 3 and 6, were air-entrained. Core 5, along with Cores 1 and 4, were not air-entrained.

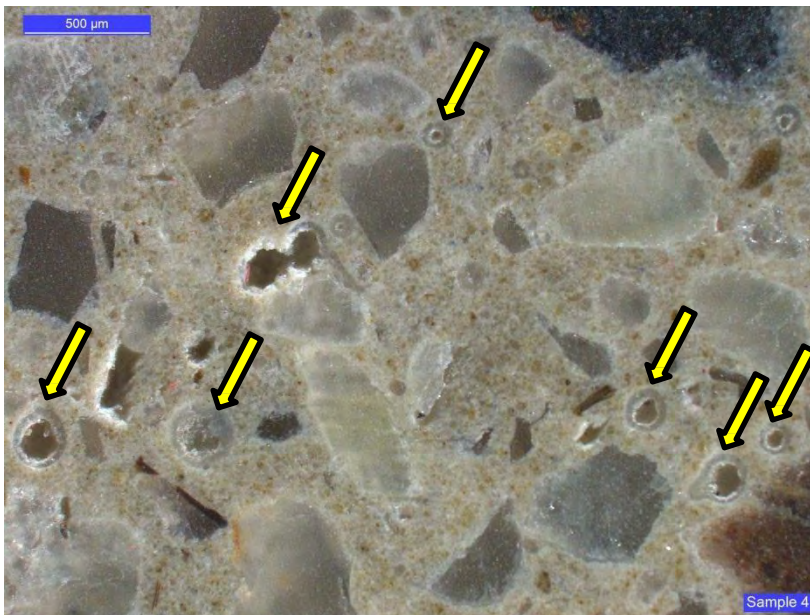
Figure 12. Air voids on the lapped surface of Core 4 are pictured. Voids are partially filled with white secondary deposits that had features consistent with ettringite (arrows). Voids filled with deposits compromise the functional air void system.

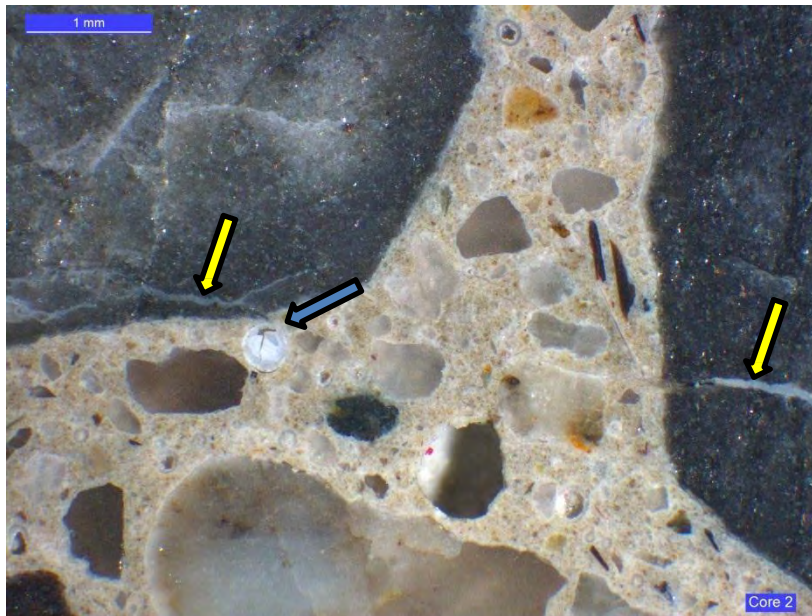
*Figure 13. A portion of the lapped surface of Core 2 is pictured. Gel-filled cracks are marked with yellow arrows in the coarse aggregates. An entrained air void intersected by a crack is filled with ASR gel (blue arrow).*

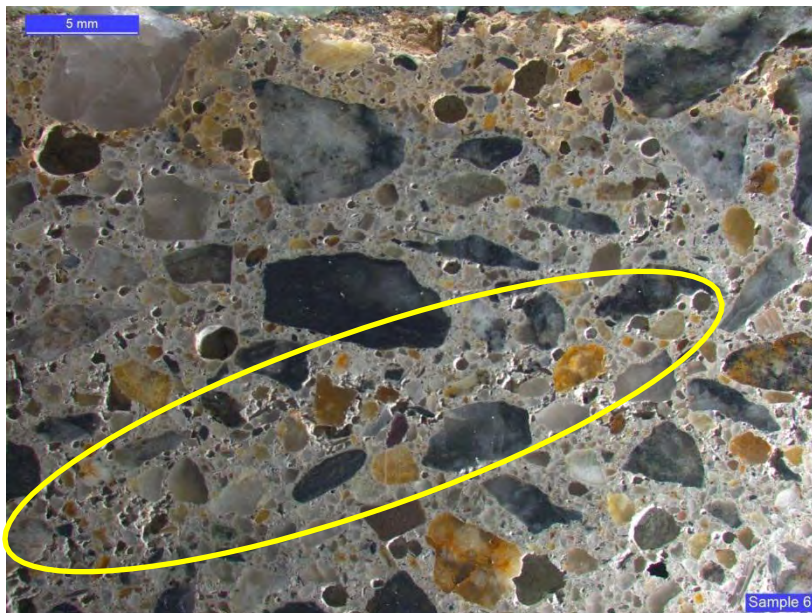
Sample 6 represents an entirely different concrete mix than the other samples. Although concrete represented by this sample has an elevated water to cement ratio and is deficient in coarse aggregate volume, it is air-entrained and does not exhibit freeze-thaw-related distress.

*Figure 14. A portion of the lapped surface in Core 6 is pictured using low-angle lighting. A band of matrix roughly 1 inch below the surface contains numerous water voids.*

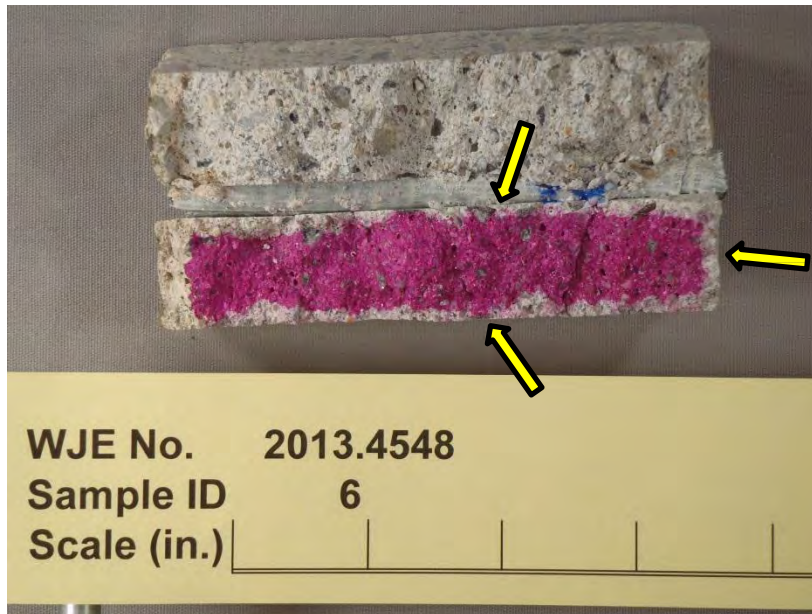
*Figure 15. A fresh fracture surface in Core 6 is pictured with the top of the core to the left of the image. Phenolphthalein indicator solution was applied to one of the fracture surfaces. The pink color indicates no carbonation of the cementitious matrix has occurred. Note the carbonation from the curved core perimeter and bottom (arrows), suggesting carbonation since the core had been extracted. This feature is consistent with a high w/c.*

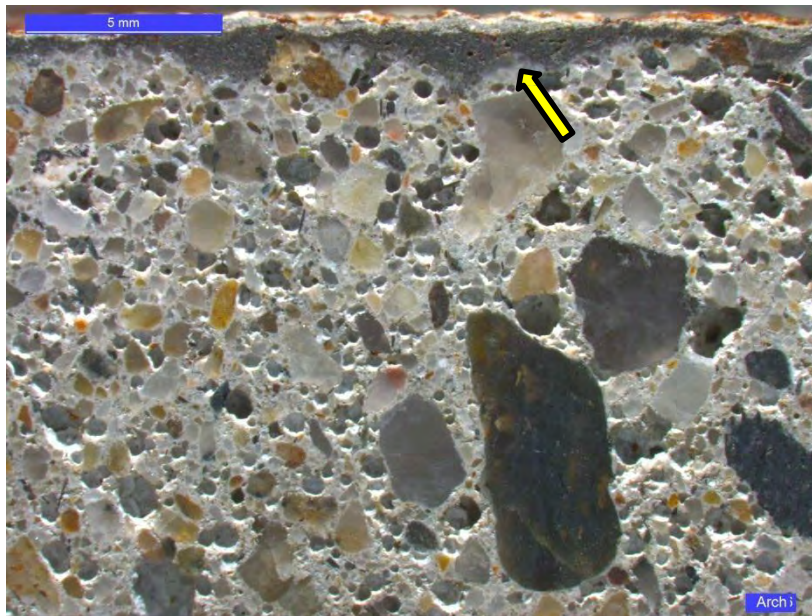
*Figure 16. A portion of the near-exterior surface of the Arch is pictured using low-angle lighting. Note the band of darkened matrix along the exterior surface (arrow). The concrete represented by the sample was air-entrained.*

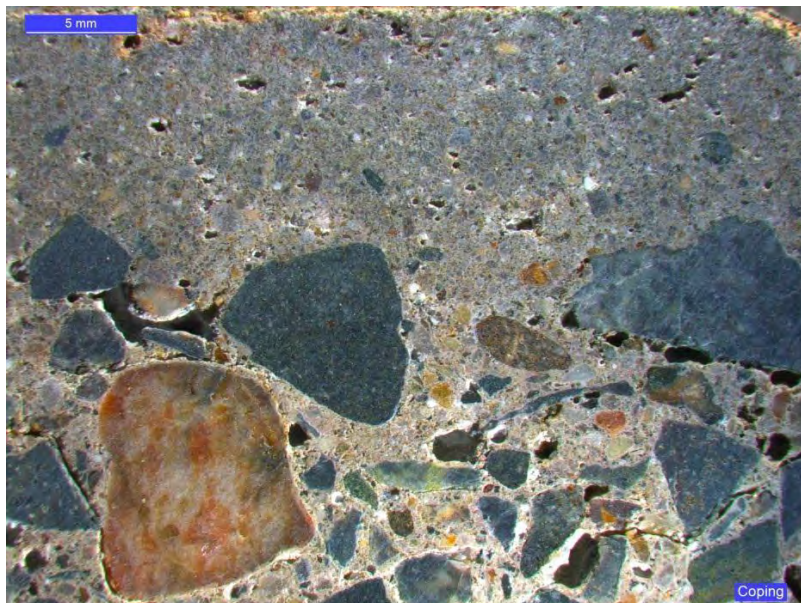
The pillar and coping samples both exhibit advanced freeze-thaw distress. Neither sample is air-entrained. There is a thin mortar layer on the horizontal surface of the coping sample that was most likely installed in an effort to increase the durability of the element. This layer has a conspicuously lower water to cement ratio than the underlying body of the concrete and would be expected to reduce water penetration into the element. Subsequent cracking of the coping allowed water penetration into the non-air-entrained body of the element.

*Figure 17. A portion of the lapped surface near the exterior surface of the Coping is pictured. Mortar was present along one of the exterior surfaces. The concrete in the body of the sample contains numerous irregularly-shaped voids. Voids are commonly lined with white secondary deposits.*

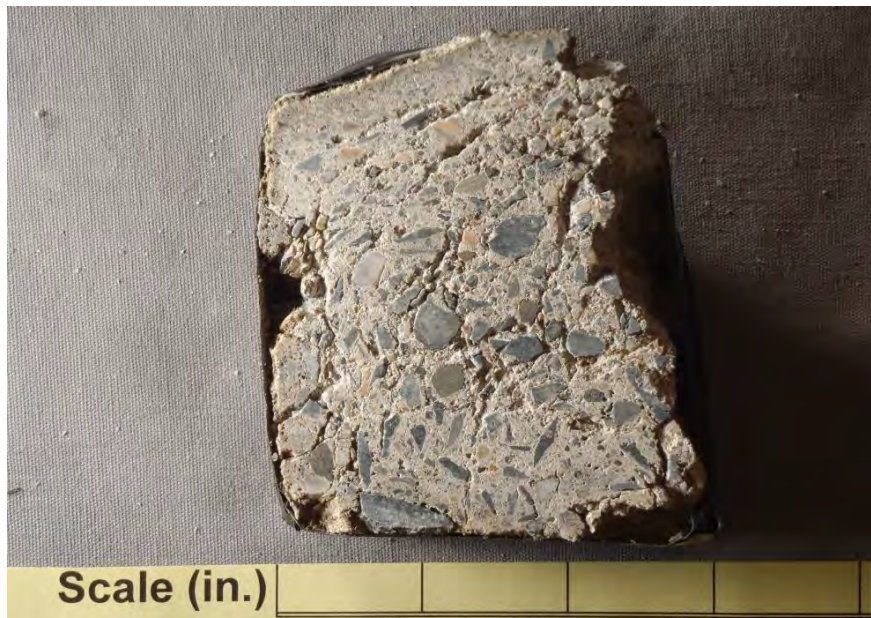
*Figure 18. The lapped surface of the Pillar is pictured using low-angle lighting. Numerous macrocracks were present through the full-depth of the sample. This deterioration is characteristic of freeze-thaw distress.*
